# Bathhouse Row Adaptive Use Program

## The Hale Bathhouse: Technical Report

BATHHOUSE ROW ADAPTIVE USE PROGRAM  
THE HALE BATHHOUSE: TECHNICAL REPORT 3

HOT SPRINGS NATIONAL PARK  
Garland County, Arkansas

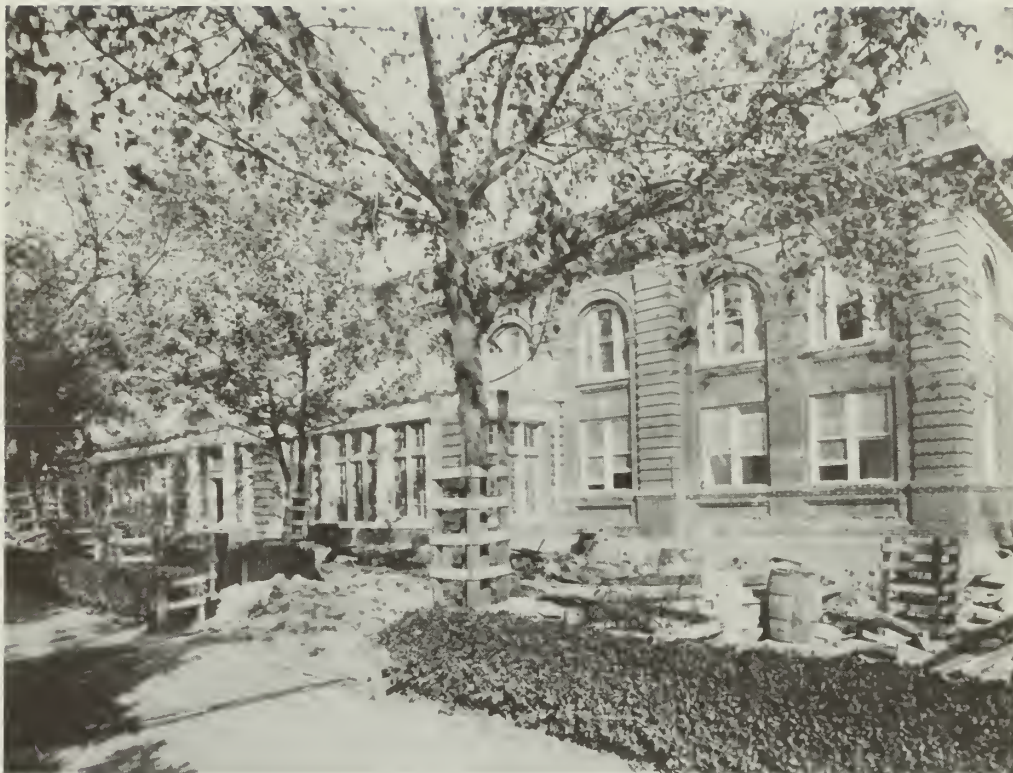
Figure 11: The Exterior of the Hale during Remodeling, 1914 (Source: National Archives, Natural Resources Division, R.G. 79)

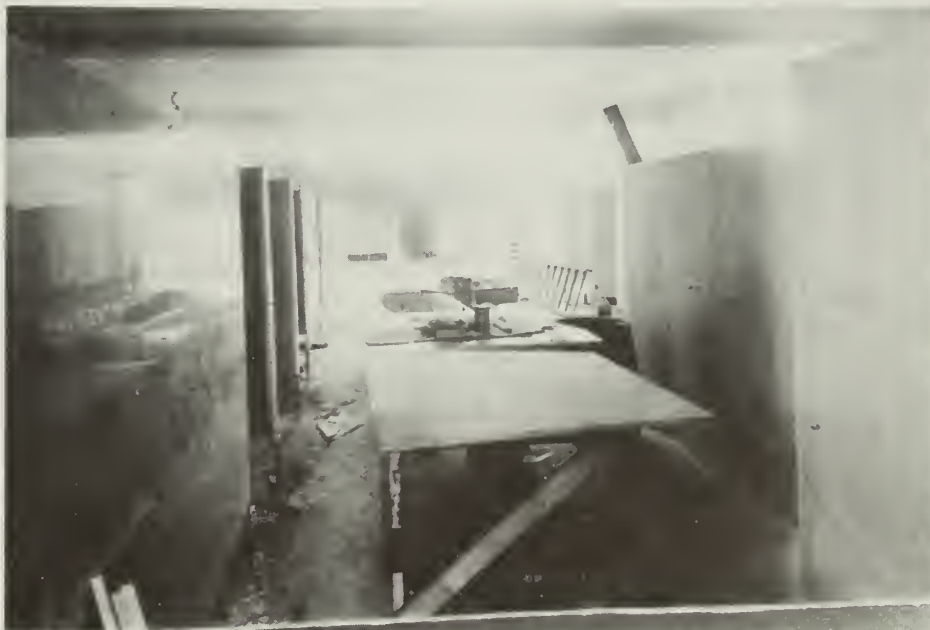
Figure 12: The Interior of the Hale during Remodeling (Men's Bath Hall), 1914 (Source: National Archives, Natural Resources Division, R.G. 79)

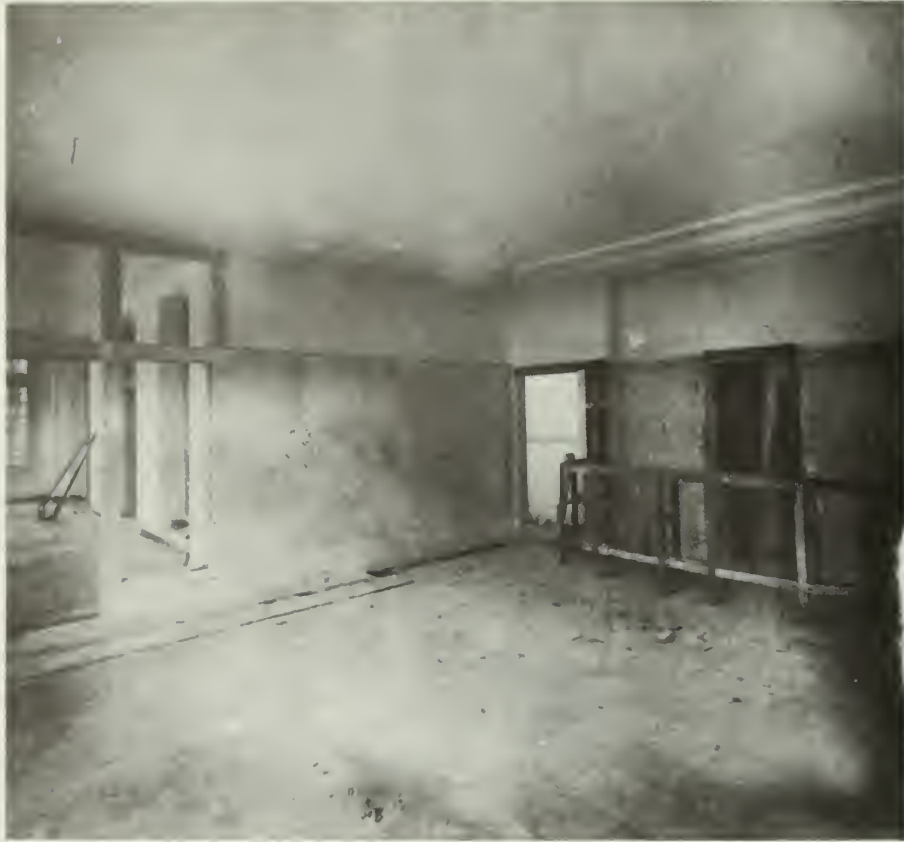
Figure 13: The Interior of the Hale during Remodeling (Office and Sunroom), 1914 (Source: National Archives, Natural Resources Division, R.G. 79)

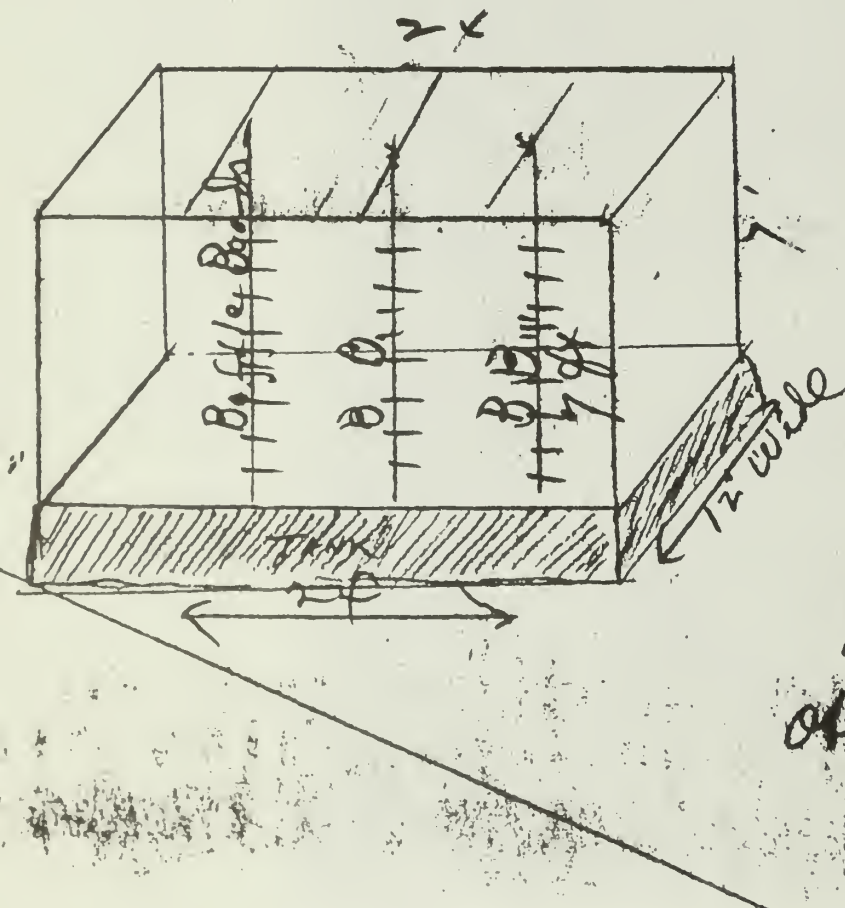
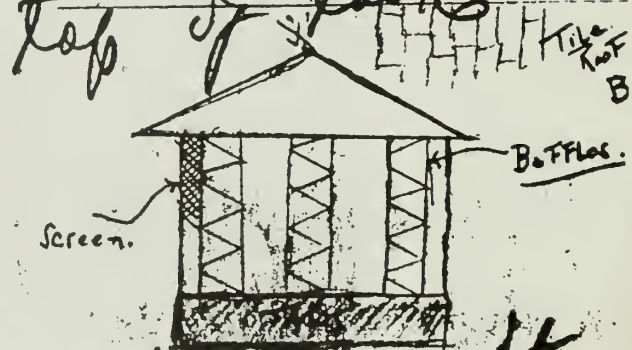
Figure 20: Changes in Cooling System, 1942 (Source: Hot Springs National Park)

Top of Bath House about 1 ft above  
Top of Tank -

this tank 7 ft  
high -  
Circular tank  
taken away was  
about 8 1/2 ft high
